WATERMEADOWS IN THE VALLEY OF THE GAVE DE GAVARNIE, FRENCH PYRENEES

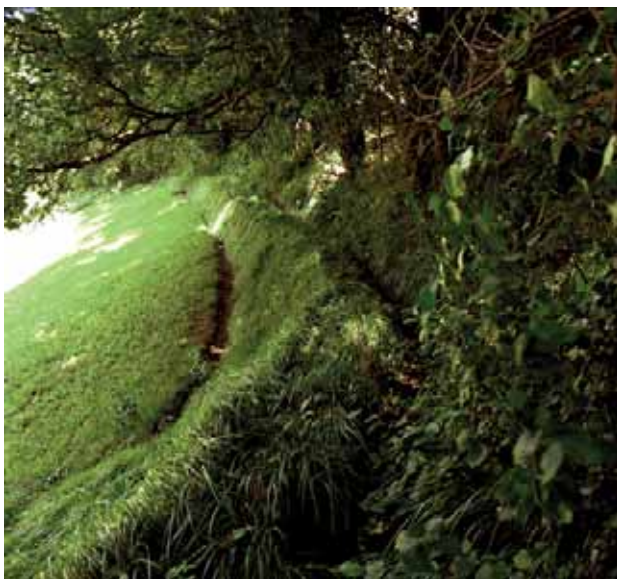
Photo 1 Double carrier arrangement near Visos, Luz St Sauveur

Double carrier
arrangement near
Visos, Luz St
Sauveur.

Not a Yeti, nor even the famously unheard of Pyrenean Snow Leopard. It was, actually, a water meadow hatch set in a simple, but familiar design of housing. It clearly controlled water entering the top end of a valley-side meadow. (Photo 1) There were in fact two parallel carriers. One to feed a succession of meadows, the lower designed to overtop and flow downslope in each meadow. A few metres downhill was a shallow trench set along the contour, presumably to collect and redistribute water from the top of the meadow.

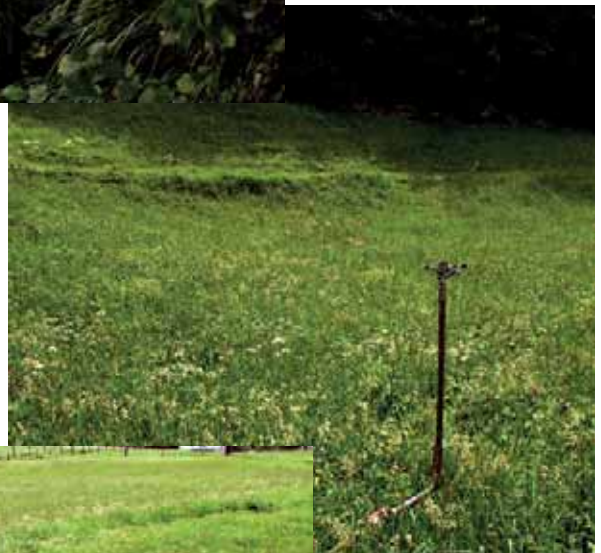
Photo 2 Old and new irrigation arrangements, east of Luz St Sauveur

Old and new
irrigation
arrangements, east
of Luz St Sauveur.

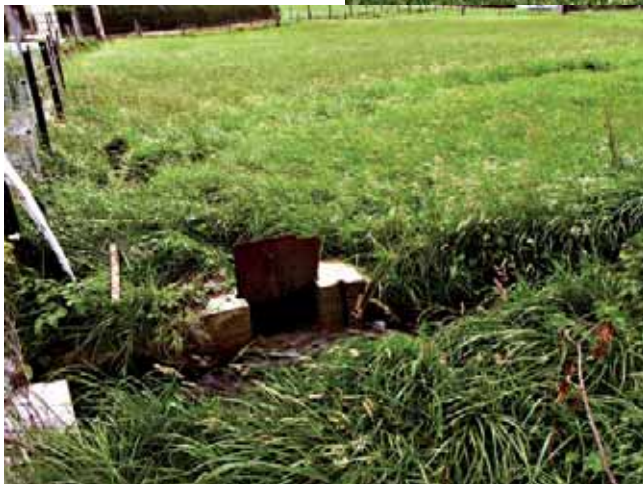
Photo 3 Hatch open, actively watered meadow August 2010

Hatch open,
actively watered
meadow August
2010.

Well, it was at least *different* from Harnham. We were actually looking at a catch meadow, or a hillside catchwork system. This general design is well known in Britain, from Scotland to Devon. I first encountered these on Exmoor, they were a part of agricultural improvements following the sale of the Royal Hunting Forest in 1818. In the eighteenth century, the South Hams district of Devon was especially famous for hillside irrigation. But were the Pyrenean meadows operational? They looked as if they might be. Then, with my eye now in, to the east of Luz St Sauveur on the road to Bareges (where the Tour de France slogs up to the Col de Tourmalet), I found another meadow, with a maturing hay crop, but sadly traditional irrigation arrangements (carrier in the background) were replaced by a sprinkler (Photo 2). Looked like cheating to me, but demonstrated the value of the summer hay crop for these mountain farmers. Next day, I crossed the road below our campsite. There was a water meadow actually under irrigation - in August. The familiar sound of running carrier (Photo 3) with an iron hatchplate lifted. I was surrounded indeed, and still on holiday!
